# Manhole Inspection Summary

Manhole # S11QQ\_040MH

Insp Date: **7/17/09 11:17 AM**

**Location** Address: **3207 VICKERS ROAD**

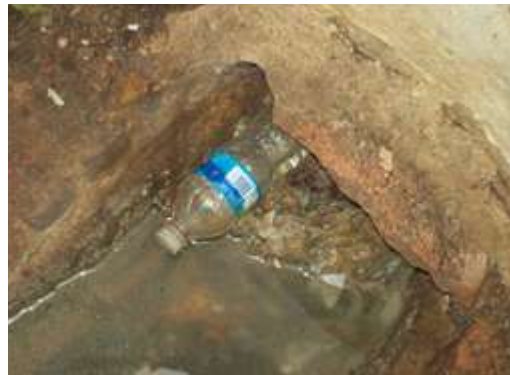
Defect 3

Condition: ☐ Sound ☐ Cracked ☐ Root Intrusion ☐ Deteriorated ☐ Leaks ☒ **Debris**

DEBRIS IN CHANNEL

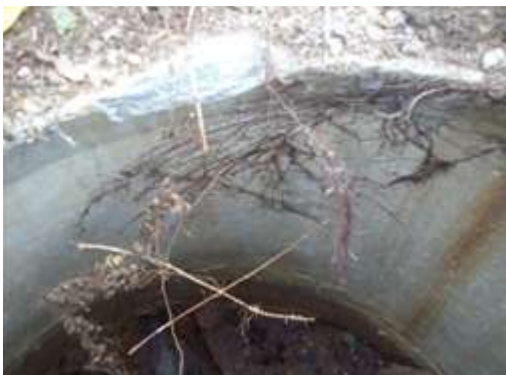
Defect 2

Condition: ☐ Sound ☐ Cracked ☒ **Root Intrusion** ☐ Loose Brick ☐ Deteriorated

Infiltration: ☐ None ☐ Joint ☐ Cracks ☐ Mortar ☒ **Roots** ☐ Wall

CORBEL ROOTS AND INFILTRATION  
AT ROOTS

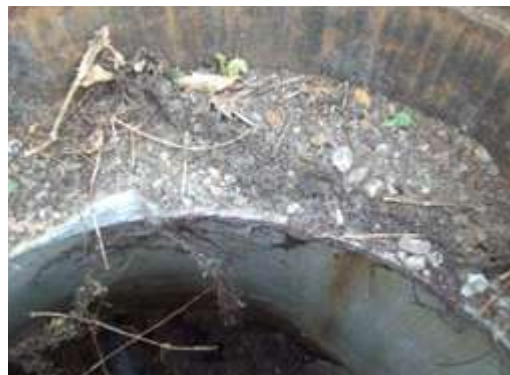
Defect 1

Offset: **5** (in.)

FRAME OFFSET

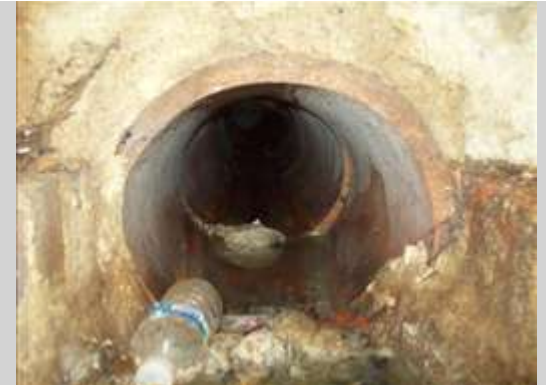
12 O'Clock Outflow

10 in. Circular Gravity Sewer  
Pipe Out @ 12 O'Clock

Invert Depth: **5.36** (ft.) Flow Characteristics: **Slow**

Infiltration: **None** Pipe Seal Cond: **Sound**

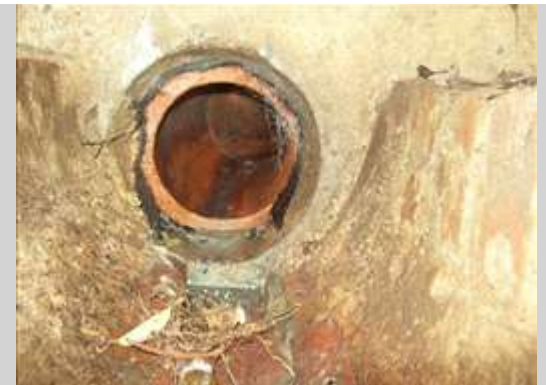
3 O'Clock Inflow

8 in. Circular Gravity Sewer  
Pipe In @ 3 O'Clock

Invert Depth: **5.44** (ft.) Flow Characteristics: **None**

Infiltration: **None** Pipe Seal Cond: **Sound**

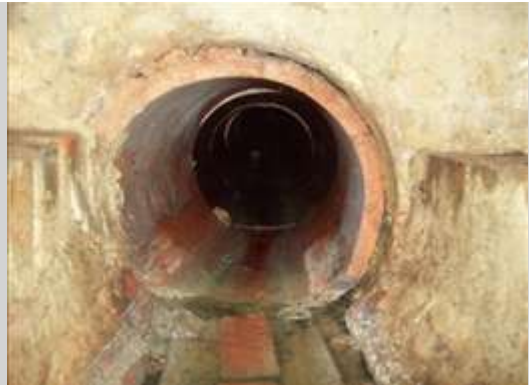
6 O'Clock Inflow

10 in. Circular Gravity Sewer  
Pipe In @ 6 O'Clock

Invert Depth: **5.42** (ft.) Flow Characteristics: **Slow**

Infiltration: **None** Pipe Seal Cond: **Sound**

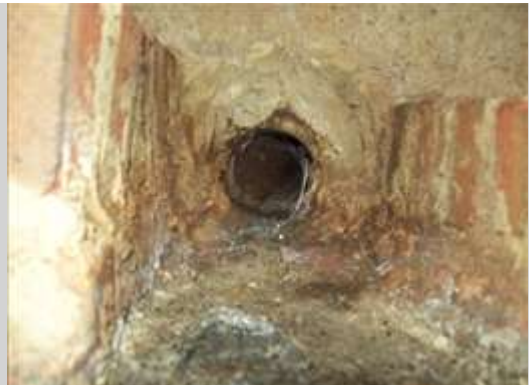
9 O'Clock Inflow

4 in. Circular Gravity Sewer  
Pipe In @ 9 O'Clock

Invert Depth: **5.26** (ft.) Flow Characteristics: **None**

Infiltration: **None** Pipe Seal Cond: **Sound**
